Accident Investigation Completed

*Reconstruction Report
Accident #2009058666
Case #2009-003825*

Columbia Police Department
Reconstruction report
Accident #2009058666

Location: Clark Lane (W), 133 feet east of
Lambeth Lane (N)

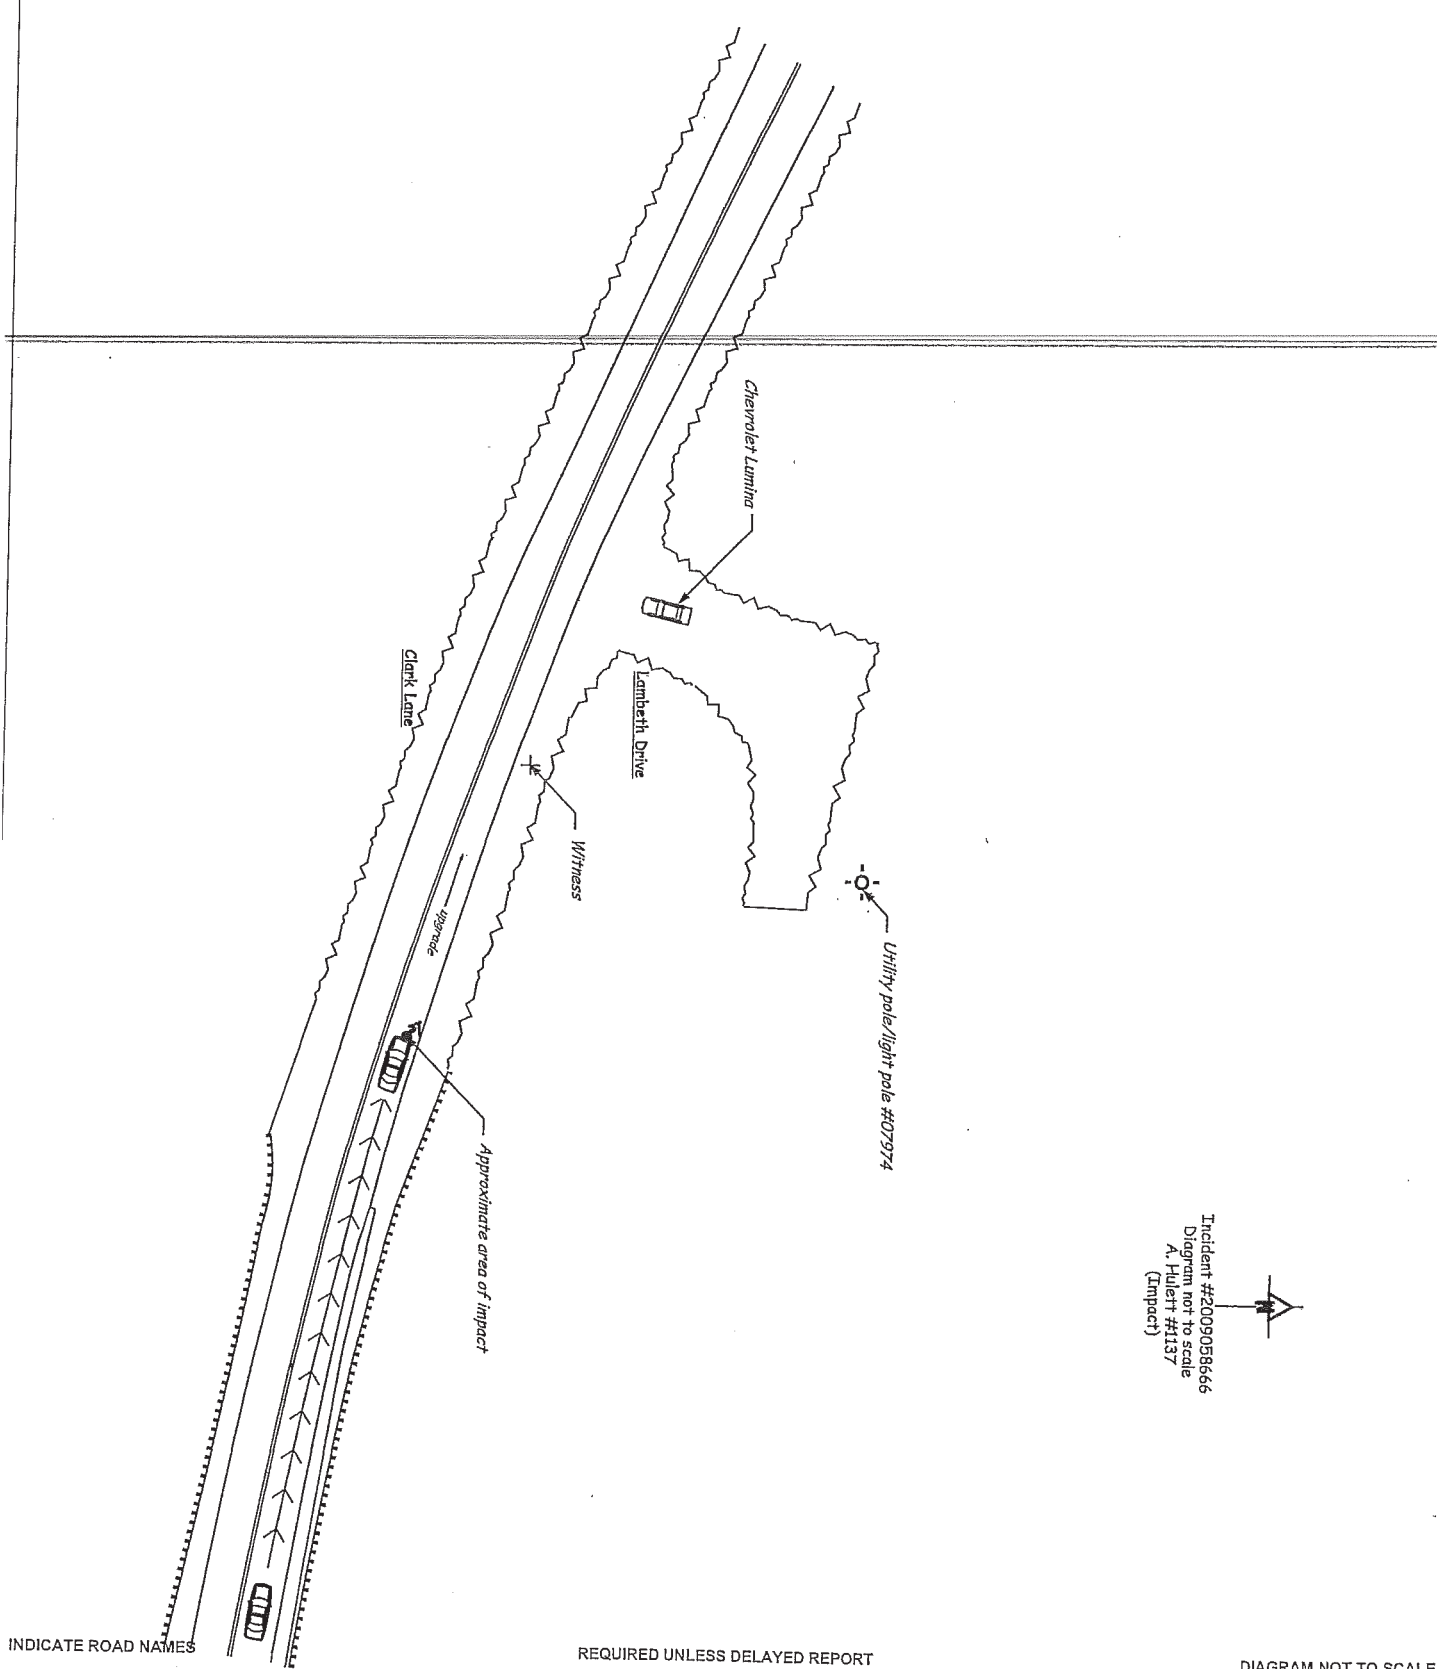
7. COLLISION DIAGRAM

Incident #2009058666
Diagram not to scale
A. Hulett #4137
(Impact)

This crash occurred as vehicle 1 was traveling west on Clark Lane near Lambeth Drive. A pedestrian was lying on his back on the main traveled portion of the road. The right front tire of vehicle 1 struck the pedestrian, rolling over his body. The pedestrian was found lying partially on the shoulder and partially on the road after the collision. The pedestrian was pronounced dead at the scene. Input Typist: HULETT, ALAN Narrative typed by: HULETT, ALAN
